# Manhole Inspection Summary

Manhole # S31KK1001MH

**Location** Address: **4338 CHARLES ST**

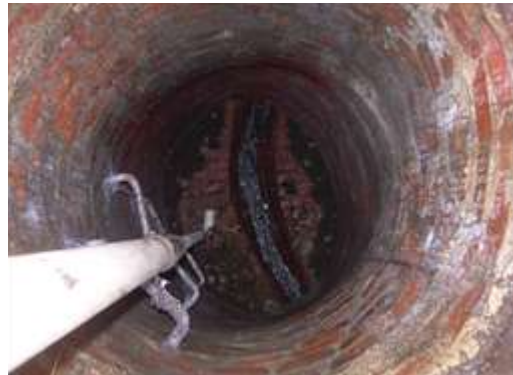
Top View

Bench debris.

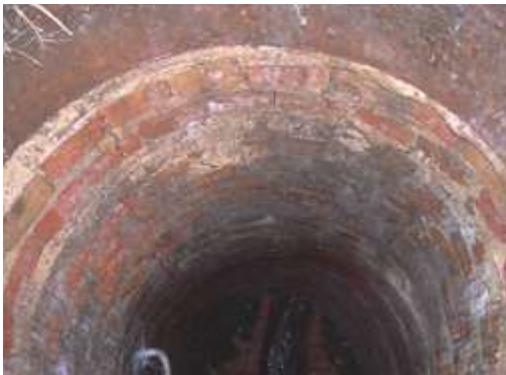
Defect

**Frame** Offset: **0** (in.) Condition: ☐ Sound ☐ Cracked ☒ **Leaks**

Infiltration: ☐ None ☒ **Joint** ☐ Cracks ☐ Mortar ☐ Roots ☒ **Wall**

Infiltration: ☐ None ☐ Joint ☐ Cracks ☒ **Mortar** ☐ Roots ☒ **Wall**

Frame leaks. Adjustment and Barrel infiltration.

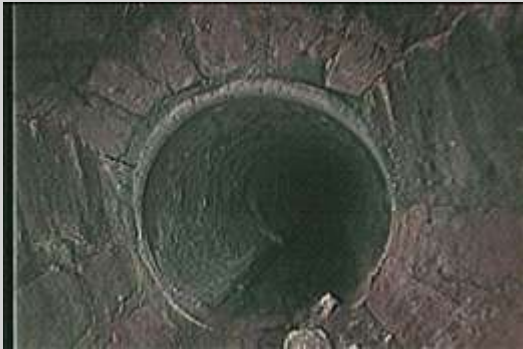
### 10 in. Circular Gravity Sewer Pipe Out @ 12 O'Clock

Infiltration: **Evidence** Pipe Seal Cond: **Cracked**
